State of California — The Resources Agency
DEPARTMENT OF PARKS AND RECREATION
PRIMARY RECORD

*Resource Name or #: K49

c. Address 8659 Brockway Vista Ave.

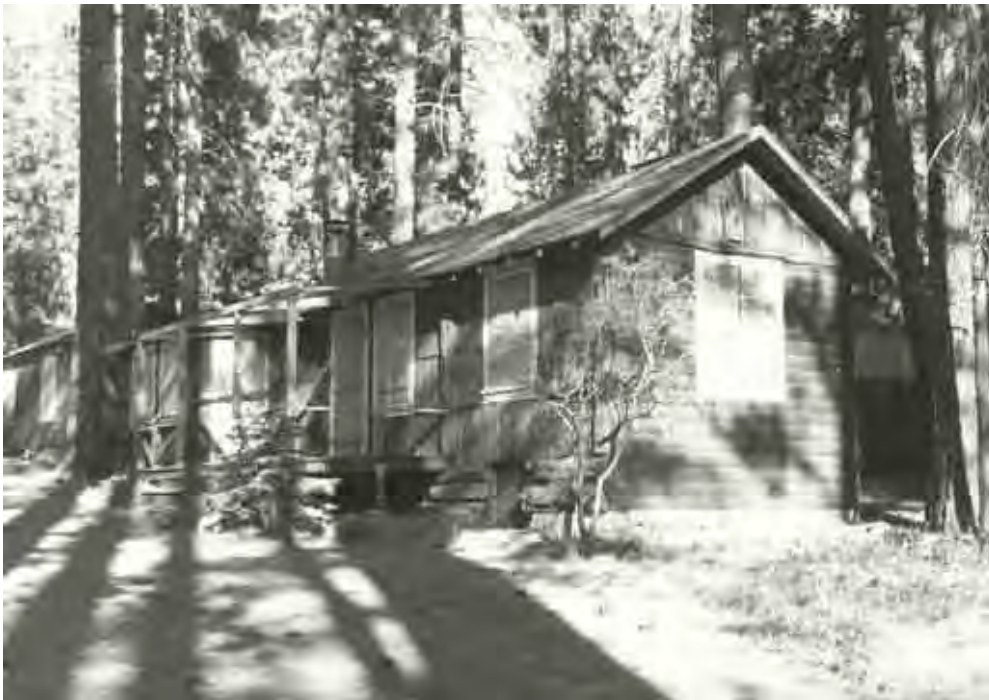
P5b. Description of Photo:
090-134-017, Building A, View NE.
Roll KBB1, Fr. 29. 10-30-02, 2:27 PM.

Building A is a one-story rectangular plan wood frame house with a basement. It has a side-gable roof with open eaves and exposed rafters, clad with composition shingles. Walls are clad with cedar bark shingles, unpeeled natural log cabin siding, and milled log cabin siding. All windows are obscured by shutters. The entrance door is shuttered and the basement door is flush. A shed addition on the north side of the house appears to be historic. The house has a front porch with supports for a seasonal fabric roof. The building has a stone fireplace. There do not appear to be any recent modifications. (continued)

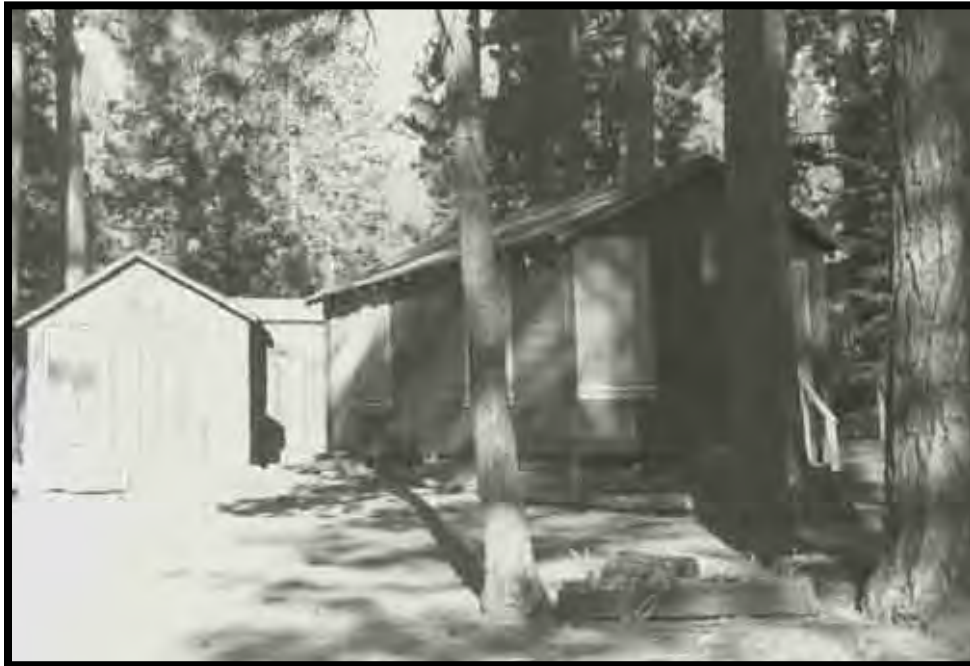
090-134-017, Building B foreground right, Garage background left. View NE.
Roll KBB1, Fr.30. 10-30-02, 2:29 PM.

Building B is a rectangular one-story rectangular plan wood frame house. It has an end-gable roof with exposed rafters and open eaves, clad with composition shingles. Walls are sheathed with stained wood V-rustic siding. All windows and the door are closed with shutters. There do not appear to be any modifications to the house.

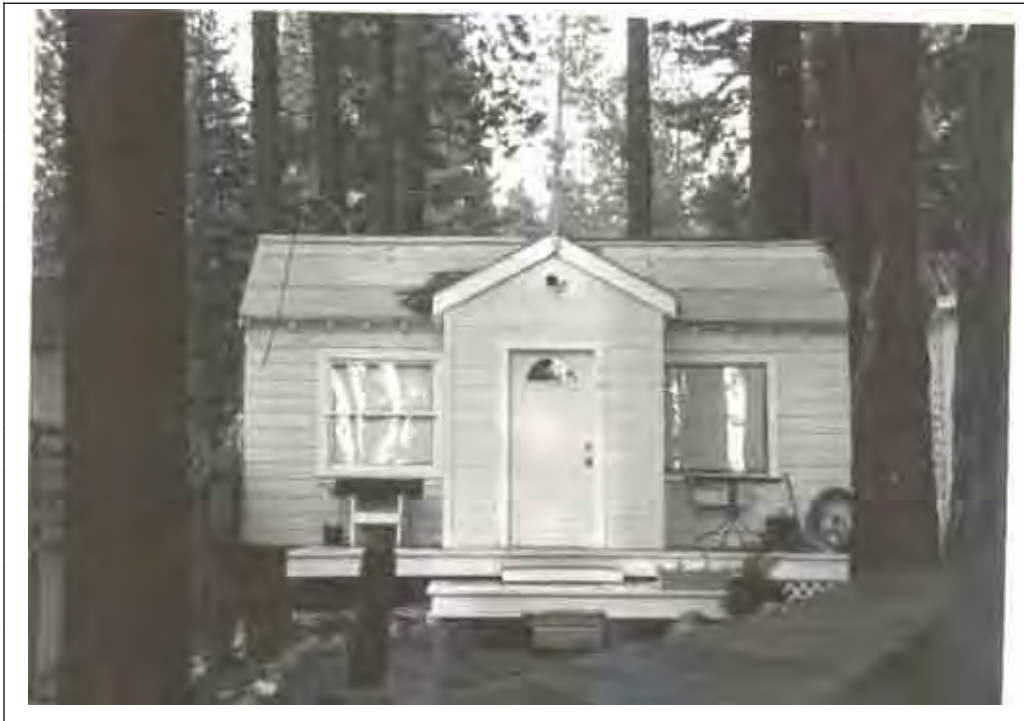
P5b. Description of Photo:
090-134-046, Building A, View North.
KBB7, Fr.20. 01-20-03, 3:20 PM.

*P3a. Description: This property includes four residences and a small shed that may have been the pump house. Much of the property is covered by native vegetation. Building A is a one-story rectangular plan wood frame house. It has a side gable roof with open eaves and exposed rafters, clad with rolled composition material. Walls are clad with painted wood drop rustic siding. Windows are 1/1 wood double-hung and recent fixed. The door is recent panel with a semi-circular light. An enclosed gable entry has been added, with plywood T1-11 siding in the gable end. (continued)

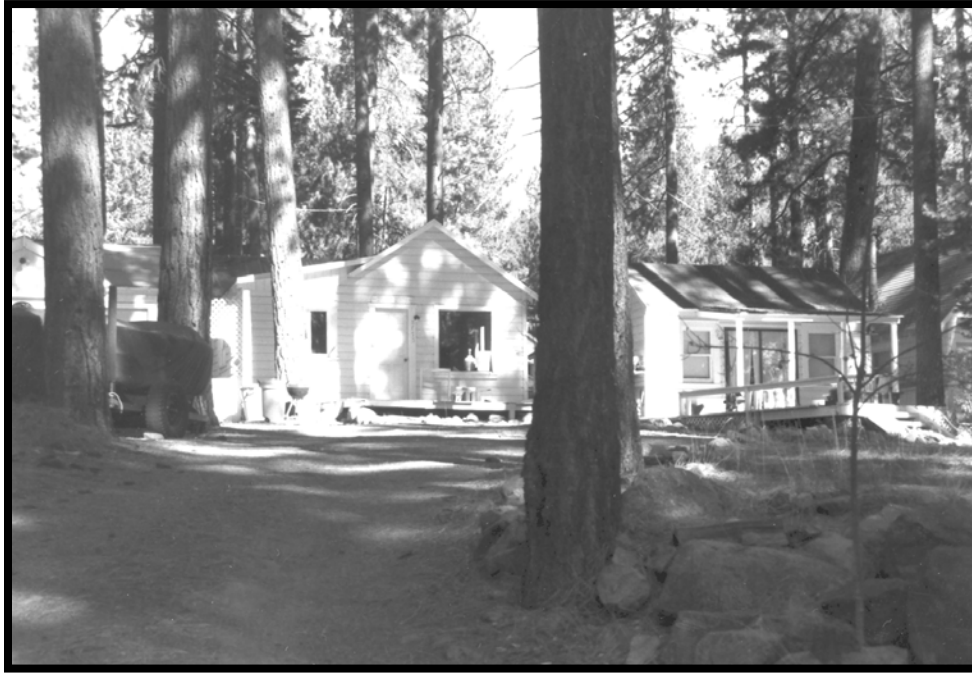
090-134-046, Building B left, Building C right. View NE.
Roll KBB1, Fr.28. 10-30-02, 12:05 PM.

Building B is a one-story rectangular plan wood frame house. It has a cross-gable roof with open eaves and exposed rafters, clad with composition shingles. Walls are clad with painted wood drop rustic siding. Windows are one pane casement pane and recent fixed. The door is wood panel. The building has two additions, a shed on the west side and a gabled addition on the north end.

Building C is a one-story rectangular plan wood frame house. It has a side-gable roof with open eaves and exposed rafters, clad with composition shingles. A recent shed entry porch supported by simple posts is on the south side of the house. Walls are sheathed with unpainted wood drop rustic siding. Windows are wood 1/1 double-hung with lambs tongue drops. The door is a glass slider. A series of wooden storage bins have been attached along the west wall.

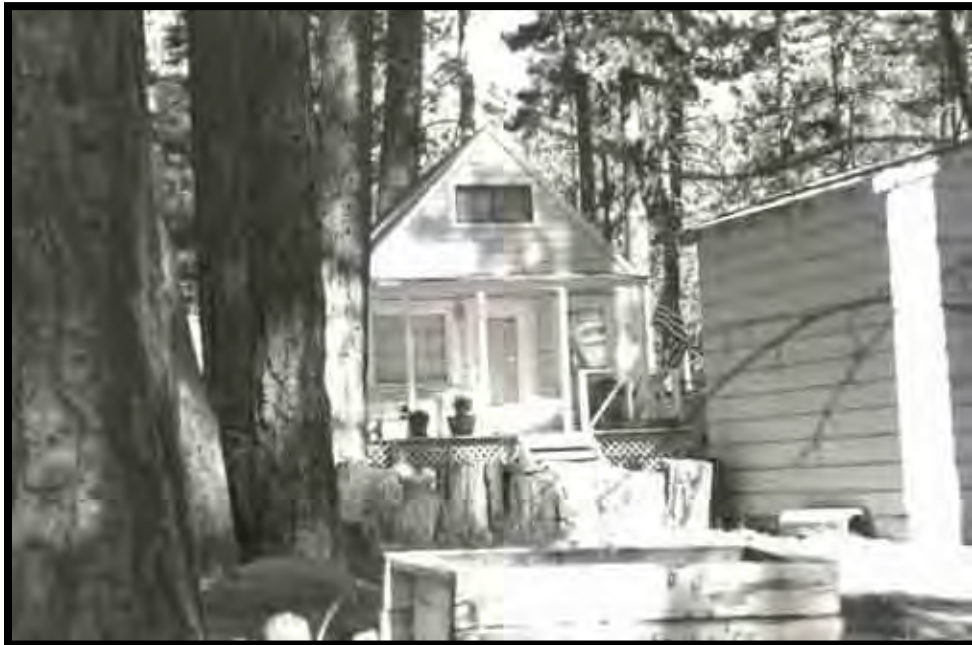
090-134-046, Building D, View NE.
Roll KBB1, Fr.27. 10-30-02, 12:00 PM.

Building D is a 1½ story rectangular plan wood frame house. It has an end-gable roof with open eaves and exposed rafters, clad with composition shingles. Walls are clad with painted drop rustic siding. Windows are wood 1/1 double-hung with lambs tongue drops, wood three light paired casement windows, and aluminum sliding. A shed-roofed porch is on the south façade. This has recent lattice skirting. A series of plywood firewood bins and a plywood utility shed are attached to the building.

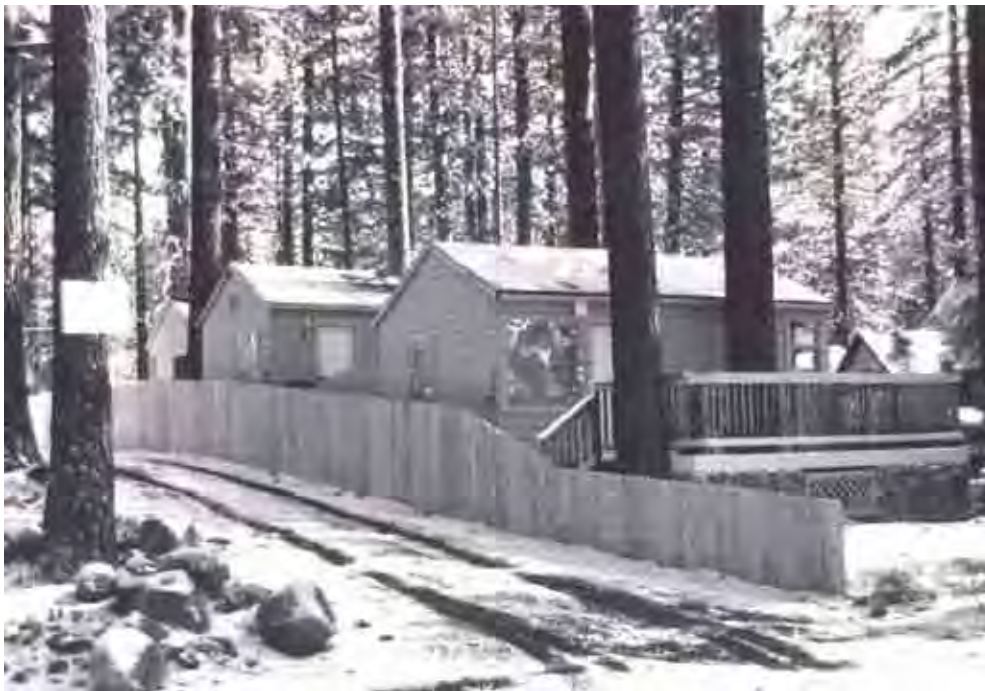
P5b. Description of Photo:
Overview, View NE.
Building "A" front, "B" rear.
Roll KBB12, Fr. 4, 3-28-03, 10:04 AM.

***P3a. Description:** This property consists of two residences on a lot with native trees and unpaved parking areas. Building A is a one-story L-plan wood frame house. It has a side-gable roof with open eaves, recent fascia, and gutters, clad with composition shingles. Walls are sheathed with painted wood drop siding. The building has wood 1/1 double-hung windows with lambs-tongue drops. The flush door is recent. A recent deck has been added, along with cobble masonry skirting around part of the foundation. A recent large utility shed is attached to the north wall and a smaller shed is attached to the east wall. Both are made of plywood. Building B is a one-story complex plan wood frame house. It has a gable roof with open eaves, and recent fascia, clad with composition shingles. Walls are sheathed with painted wood drop siding. The building has wood 1/1 double-hung windows with lambs-tongue drops. The flush door is recent. A recent deck has been added, along with cobble masonry skirting around part of the foundation. Four small plywood shed additions cover half of the east wall.

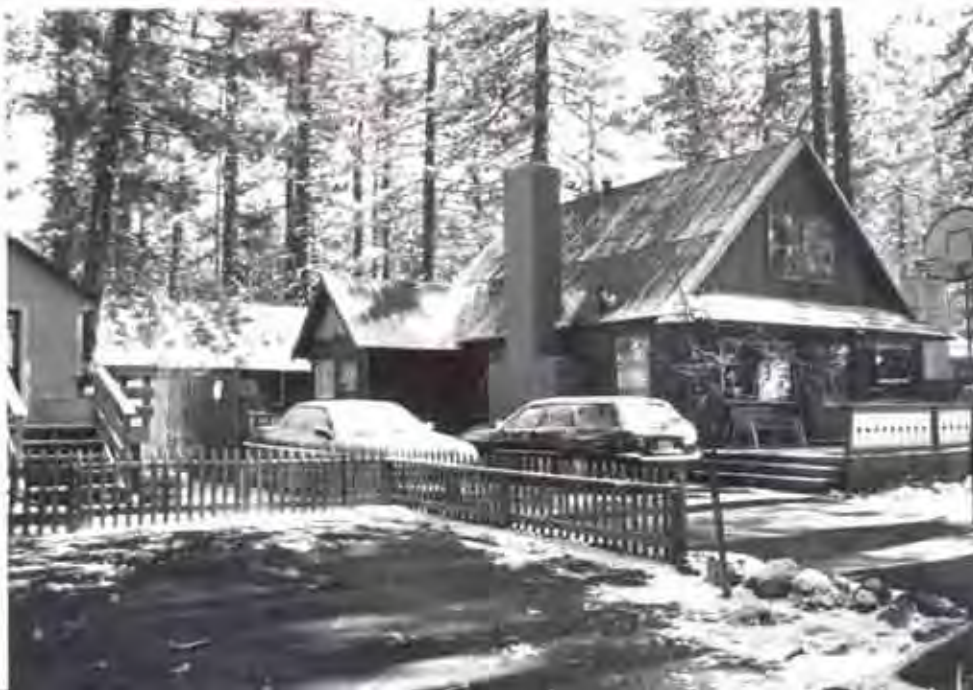
090-134-023, View NE.

Building A is a 1½ story L-plan wood frame house. It has an end gable roof with open eaves and exposed rafters, clad with painted corrugated metal sheets. A narrow shed roof clad with shake shingles covers the shallow combination entry and bay window and extends the entire length of the south façade. Walls and gable ends are sheathed with painted V-rustic siding. The building has 6/1 and 1/1 wood double-hung windows along with recent large horizontally oriented fixed picture windows, recent storm windows, and a recent aluminum slider. Doors are wood panel with lights, recent metal storm, and recent panel with lights. A gable addition is on the west side. The building has a large wood front deck and a recent external cinder block chimney.

Building B is a one-story rectangular plan wood frame house. It has a side gable roof with fascia, clad with painted corrugated metal panels. Walls are sheathed with painted V-rustic siding. The building has aluminum sliding windows, recent flush door, and a wood front porch.

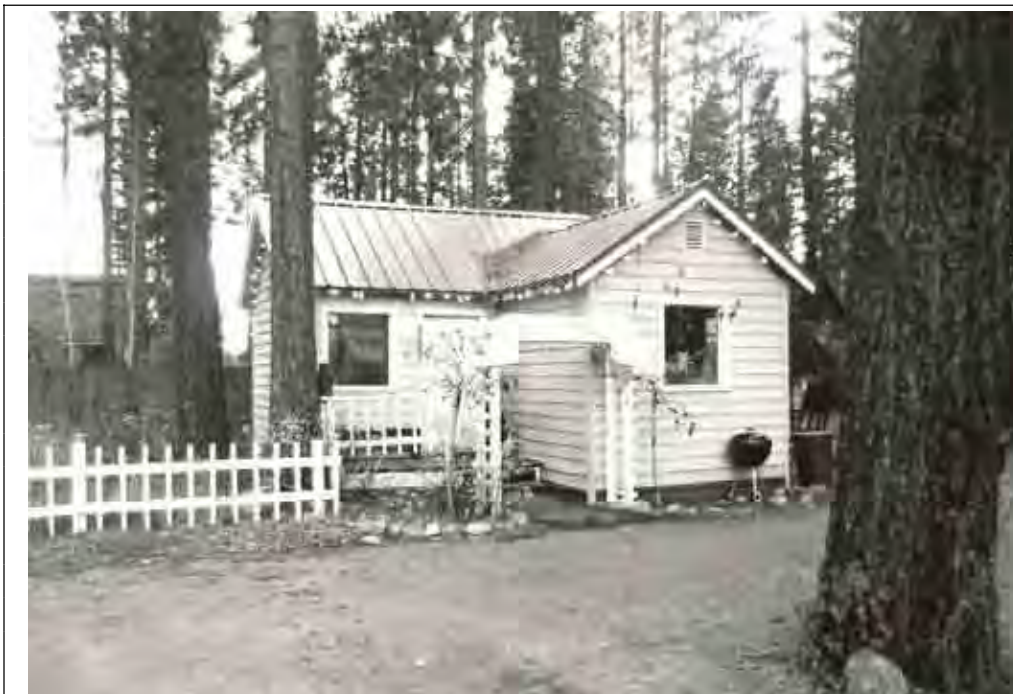
P5b. Description of Photo:
090-134-030, Building A, View SW.
Roll KBB4, Fr. 15. 11-14-02, 3:50 PM.

***P3a. Description:** This property includes two small businesses, in what appear to have originally been residential buildings, and an outbuilding. They are set on a lot that is mostly paved parking but supports some native trees. Building A is a small one-story L-plan wood frame house. It has a cross-gable roof with exposed rafters and open eaves, clad with standing seam metal. The building is sheathed with wood lap siding. Original windows are wood 1/1 double-hung, but both windows on the front façade have been replaced with fixed single light windows. The door is clad with wood V-rustic siding. The house has a recent (c.1990s) picket fence and trellis entry bearing the business sign. (continued)

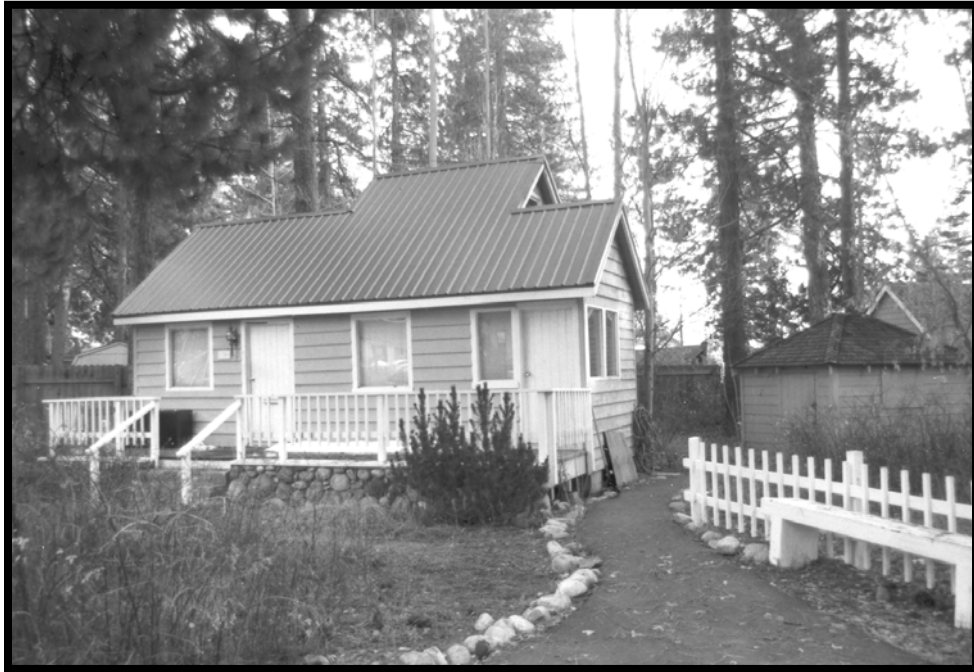
090-134-030, Building B, View E.
Roll KBB4, Fr.14. 11-14-02, 3:50 PM.

Building B is a 1½-story rectangular plan wood frame house. It has a side gable roof with open eaves and fascia, clad with standing seam metal roofing. Walls are sheathed with wood lap siding. All visible windows are fixed single light. The door is clad with wood V-rustic siding. An open porch with simple railings and cobble foundation extends the width of the main facade

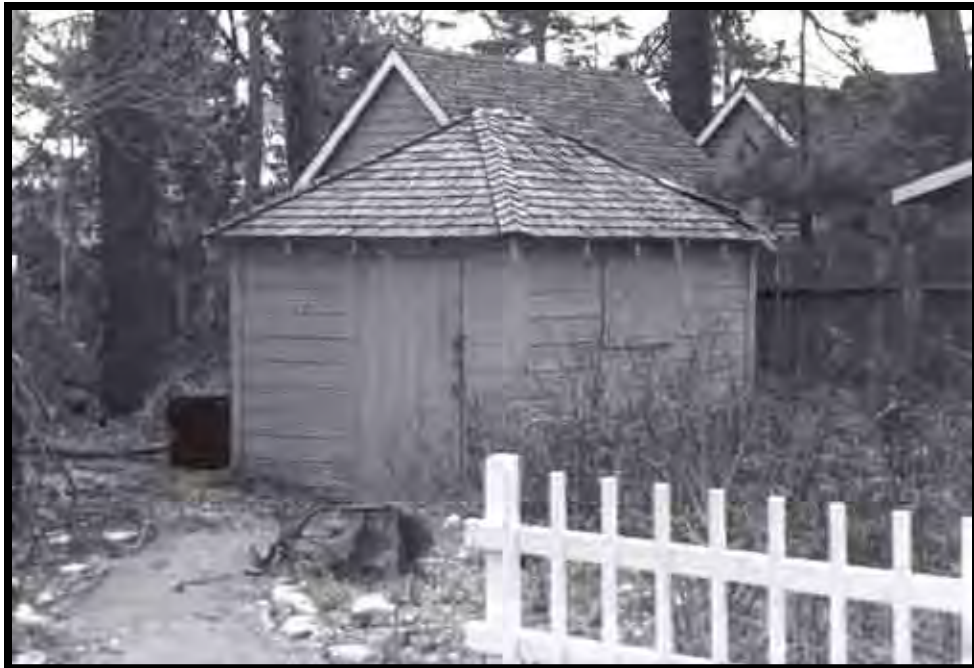
090-134-030, Pump House, View SE.
Roll KBB11, Fr.9. 04-01-03, 11:40 AM.

Adjacent to Building B is what appears to be a pump house. It is one-story, rectangular in plan, and of wood frame construction. It has a hip roof with open eaves and exposed rafters, clad with milled wood shingles. Walls are low and sheathed with wood V-rustic siding, as is the door. The window has been boarded over.

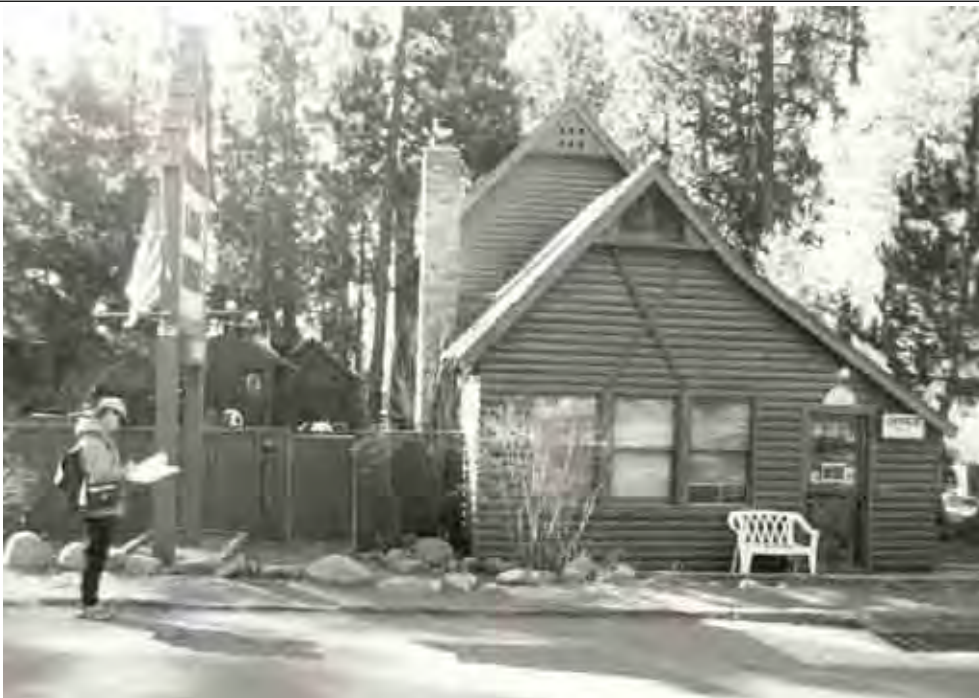
090-142-001, View South.

***P3a. Description:** This property is presently part of the North Lake Lodge, which includes the lots to the east and south. Portions of the lots not used for parking support native trees. The building is a two-story rectangular plan wood frame motel. It has a gable roof with open eaves and exposed rafters, clad with composition shingles. Walls are clad with stained log cabin siding. Windows are wood 1/1 double-hung and wood sliding. Four windows have been replaced with metal sliders. Doors are recent X-panel with lights. There appear to have been several additions, but all appear historic. The building has two brick fireplaces, of which the northern one appears recent. The building has a large open porch. Recent lattice has been added to the railings.

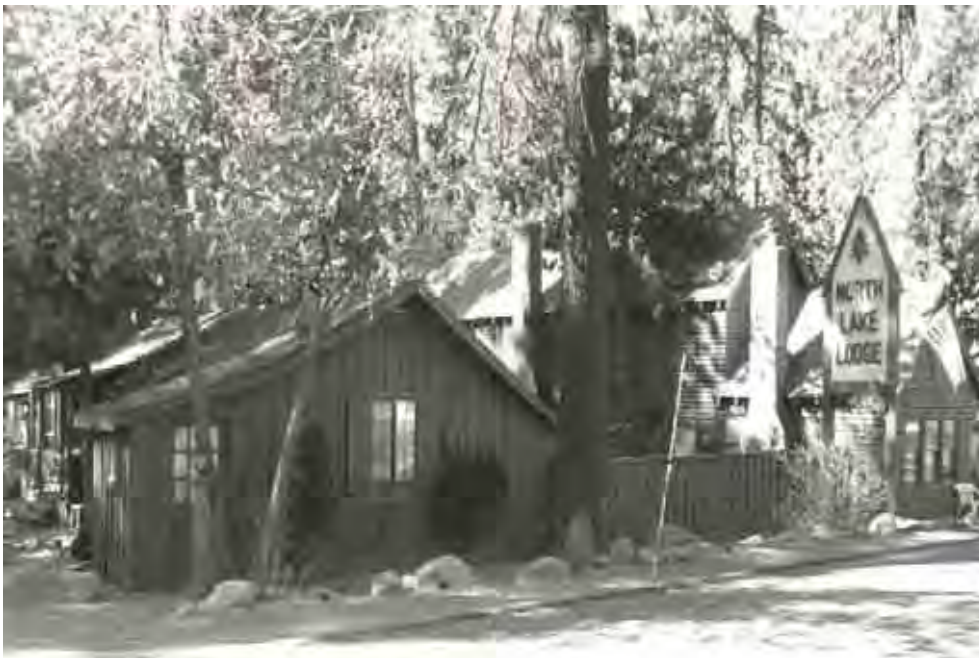
P5b. Description of Photo:
090-142-002, Building A, View SW.
Roll KBB1, Fr.8. 10-30-02, 10:05 AM.

Building A is a one-story building with multiple rental units. It has a complex plan due to several additions linking what appear to have been several previously separate buildings. It has a cross-gable roof with open eaves and fascia, clad with composition shingles. The walls are sheathed with stained board and batten siding except for plywood T1-11 on the south end. Windows include wood casement with various numbers of lights, metals sliders and metal 1/1 double-hung. Doors include V-rustic, panel, and flush with two lights. Recent (c. 1990s) doors are X-panel with lights. A porch has been added. (continued)

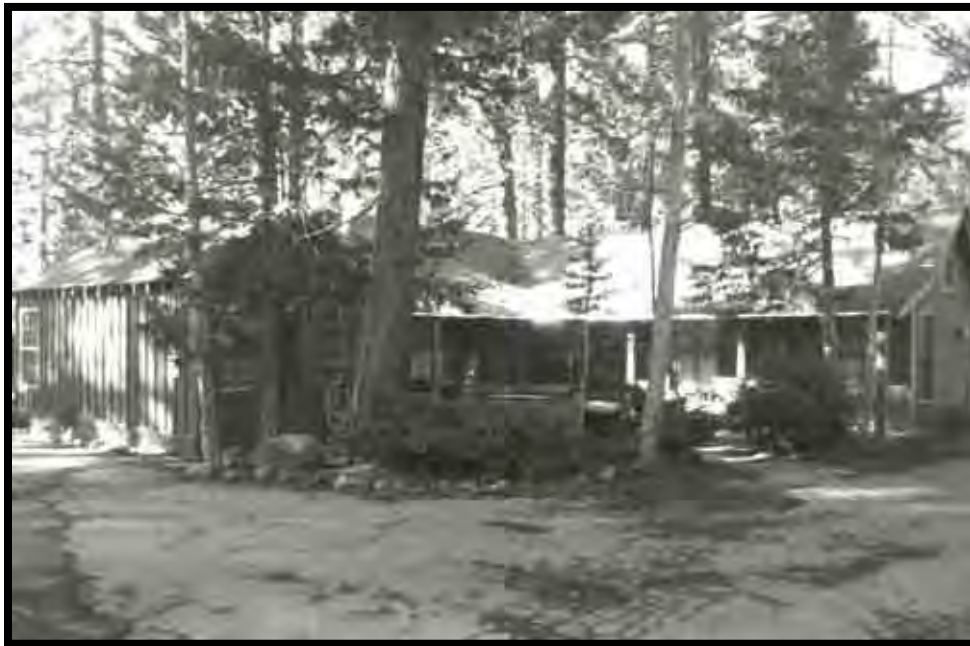
090-142-001, Building B, View SW.
Roll KBB7, Fr.17. 01-20-03, 10:50 AM.

Building B is a one-story L-plan wood frame building housing three rental units. It has a cross-gable roof with open eaves and exposed rafters, clad with composition shingles. Walls are sheathed with stained board and batten siding. Windows are six light wood casement and wood 1/1, 2/2, and 4/4 double-hung. Doors are panel. One window has been equipped with a metal storm window. There do not appear to be any other recent modifications.

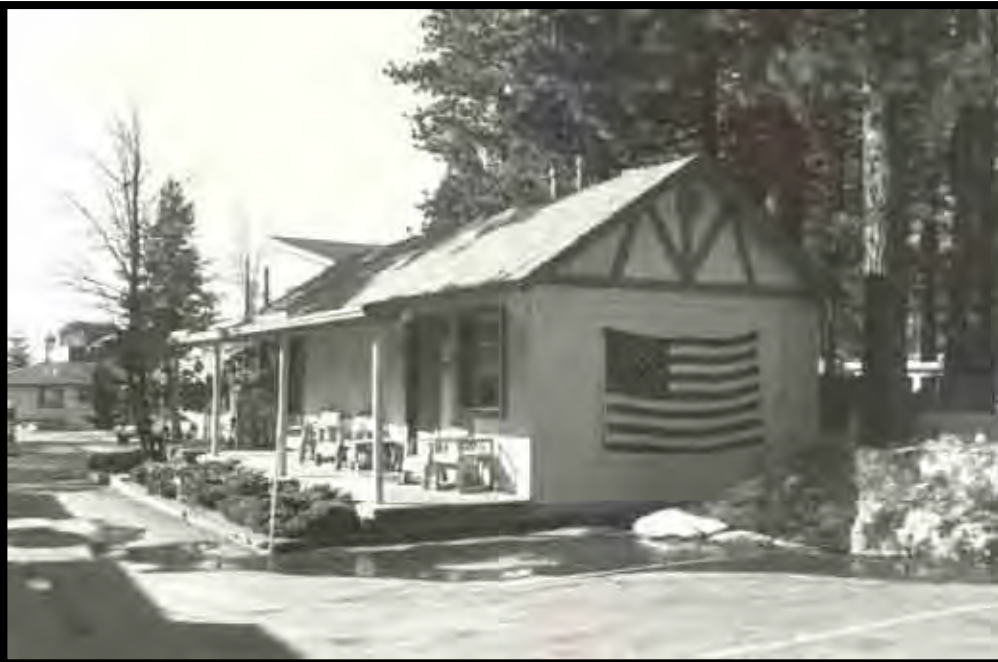
Building B, View SW.

Building B is a one-story rectangular plan wood frame building. It has a side gable roof with open eaves and gable ends partly covered by a recent fascia. A recent porch supported by simple posts extends along the entire east side of the building. Walls are sheathed with painted wood V-rustic siding. Recent contrasting trusswork trim has been added to the gable end. Windows are aluminum sliders and the doors are recent flush. A small shed has been added to the south end of the building.

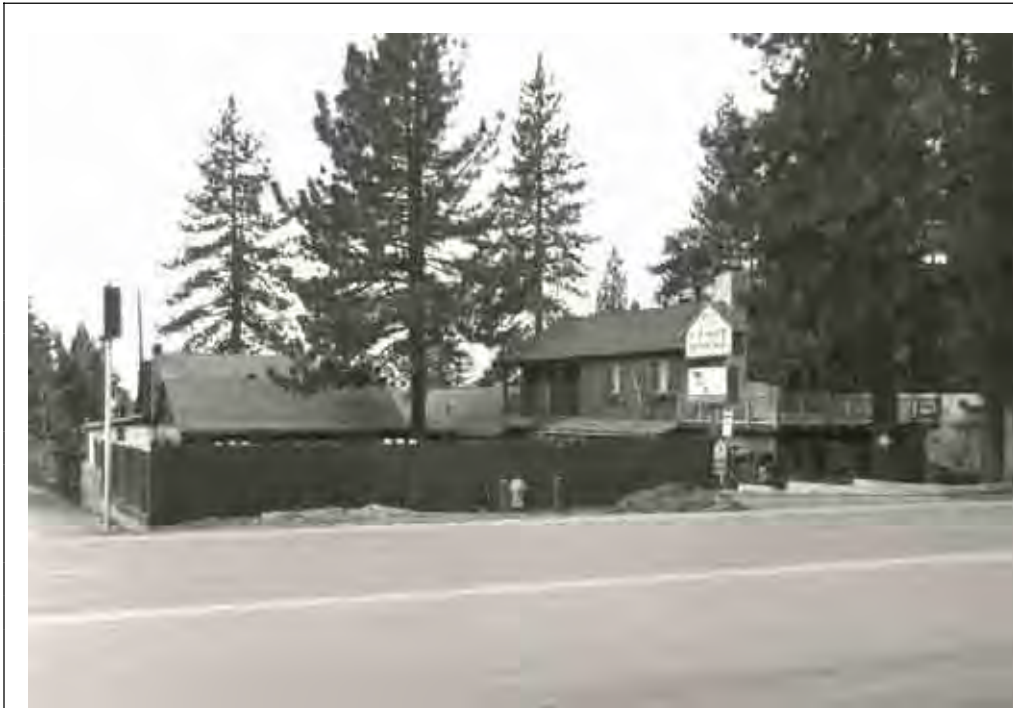
090-142-026, View SW.

***P3a. Description:** This building is a one and two-story L-plan cinder block motel. As originally built, it was one-story with all walls made of cinder blocks with rounded corners. It has a gable roof with open eaves and exposed rafters, clad with composition shingles. Gable ends are clad with stained wood V-rustic siding. Original windows are metal casement, but many have been replaced with aluminum sliders. Doors are flush. The entire second story is a gabled addition, clad with plywood T1-11 siding. It has aluminum sliding windows and patio doors and a cinder block chimney. At the north end of the building is a second addition. This is one-story with a flat roof that doubles as a deck. It has milled shingle siding, aluminum sliders, and peeled log railings. A third addition is a shed-roofed enclosed entry porch. The original porch above entries all along the rear of the building is supported by pillars made of rounded-corner cinder blocks. There is a concrete pool at the northeast corner of the property. Cinderblock and cobble retaining walls and planters have been added. A few native trees survive at the rear of the lot. The sign is recent (c.1990s).

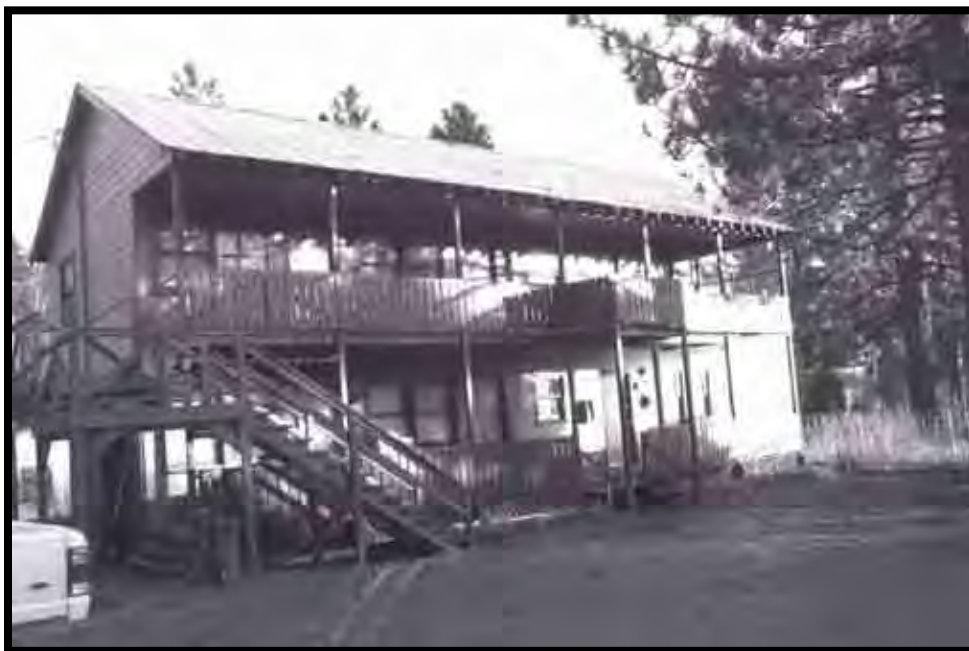
090-142-007 Building B, View SE.
Roll KBB4, Fr.16. 11-14-02, 3:55 PM.

Building B is a two-story rectangular plan wood frame apartment building. It has a side-gable roof with exposed rafters and open eaves, clad with recent aluminum panels. The building has a full-length covered porch supported by simple posts with vertical board railing. Walls are clad with painted wood lap and V-rustic siding. Windows are wood 1/1 double-hung, some of which are covered with metal storm windows or temporary plastic sheets.

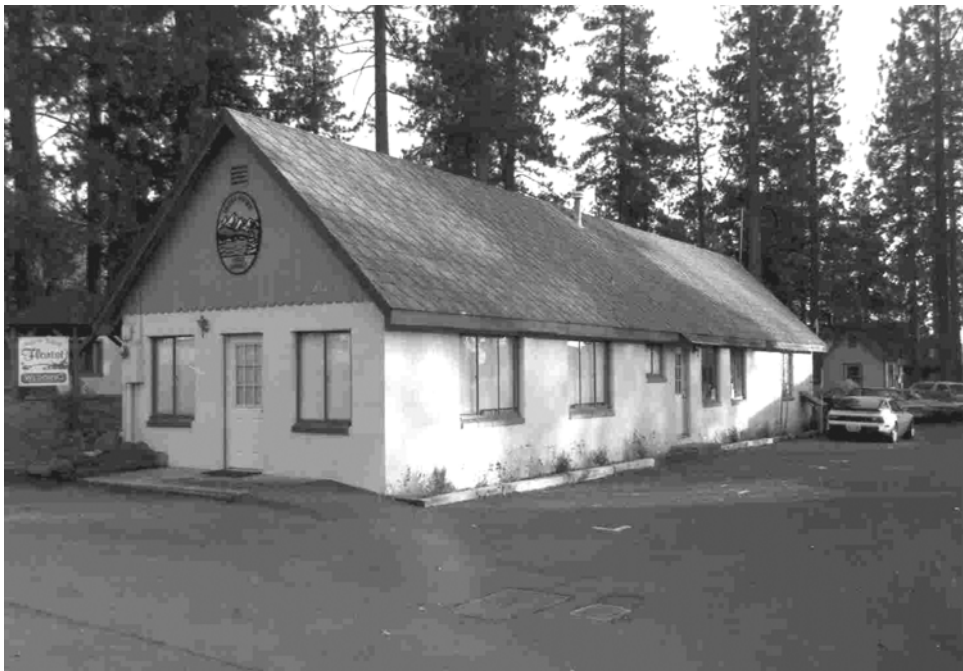
090-221-018, View SE.

***P3a. Description:** This building is a one-story rectangular commercial structure made of rounded-corner cinder block. It has a gable roof with open eaves and fascia clad with locking composition shingles over an older layer of standard tab composition shingles. Walls are unsheathed block except for the gable ends, which are of painted wood V-rustic siding. Windows are steel 2 and 3 light casement. The door is panel with lights. A metal exterior chimney has been added. The entire lot is paved.

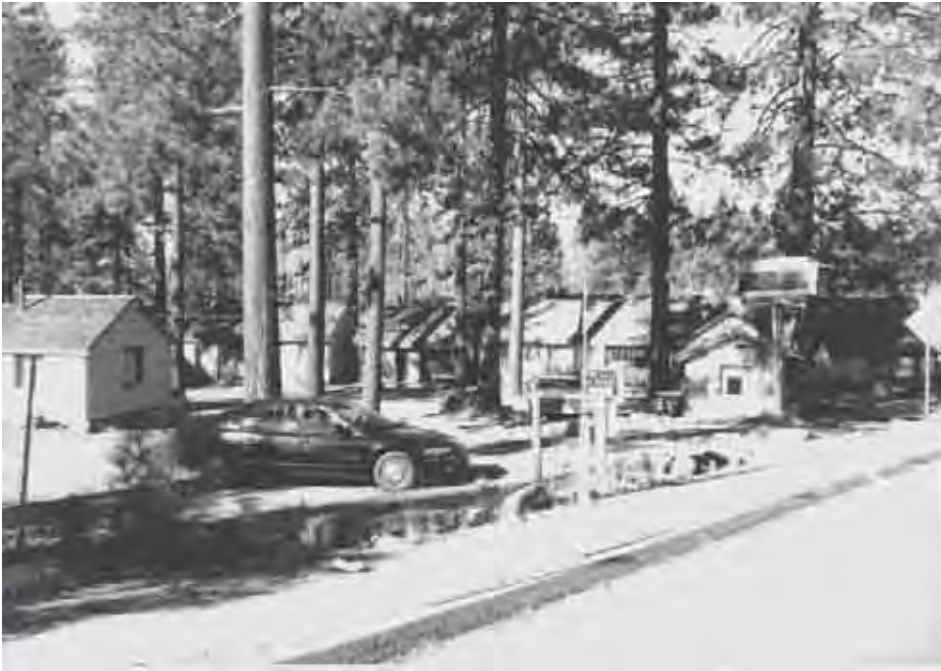
P5b. Description of Photo:
Overview from SR 28, facing SW.
KBB1 Frame 2

The Brockway Pines Motel was an auto court consisting of at least 7 small rustic cabins arranged around a central parking area.

*B6. Construction History: Assessor's Year Built: Ranges from 1926-1962. Buildings D and E are shown on the 1936 Hwy map. "Brockway Pines Cottages" Mulford K. Miles, proprietor is listed in the 1946 phone book. The business under this name continues to be advertised in phone books for 1952 through 1955 (later years not checked). This suggests the property evolved from two individual residences to a cottage complex. Evolution continued with extensive remodels (c.1990s) of all buildings except F. The Brockway Pines Motel sign is in very poor condition, indicating many years since the place operated as a motel.

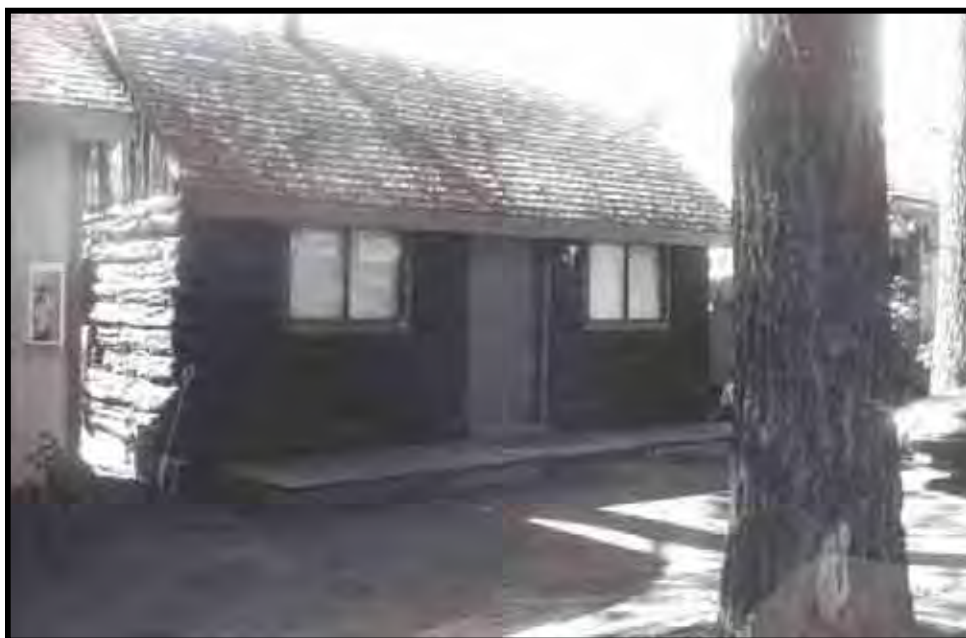
Building B (Front), View NW, KBB13, Fr. 24,

Building B is a one-story wood frame house matching the description for the north half of Building A except that the windows have been replaced with metal sliders.
